Manhole Inspection Summary

Manhole # S1900_017MH

Insp Date: **7/6/07 11:10 AM**

Location Address: **2105 WHITTIER-ELGIN**

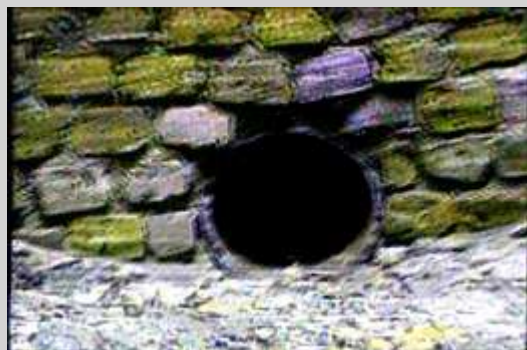
12 O'Clock Outflow

8 in. Circular Gravity Sewer
Pipe Out @ 12 O'Clock

Pipe Height: **8.4** (in.) Rod and Bar (Angled)

Pipe Material: **Clay** ☐ Pipe Lined

Infiltration: **None** Pipe Seal Cond: **Sound**
